# Manhole Inspection Summary

Manhole # S67S\_\_011MH

Insp Date: **4/9/08 11:21 AM**

**Location** Address: **6300 Danville St.**

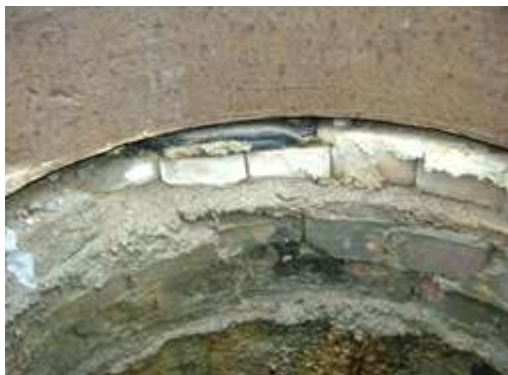
Defect 3

Condition: ☐ Sound ☐ Cracked ☐ Root Intrusion ☒ **Loose Brick** ☒ **Deteriorated**

Deterioration of chimney.

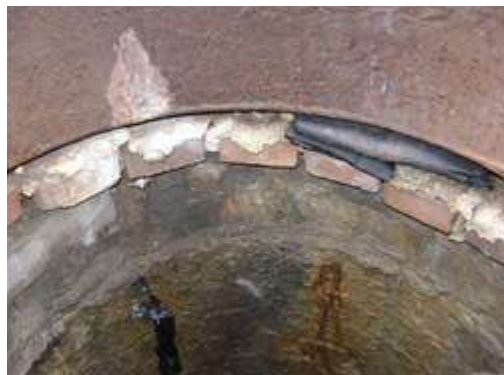
Defect 4

Loose bricks--chimney/frame

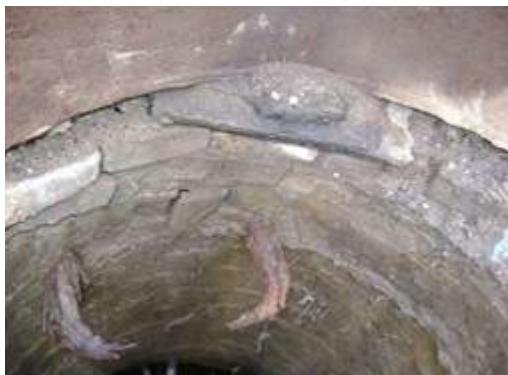
Defect 5

Offset: **1.5** (in.)

Condition: ☐ Sound ☒ **Cracked** ☐ Leaks

frame offset

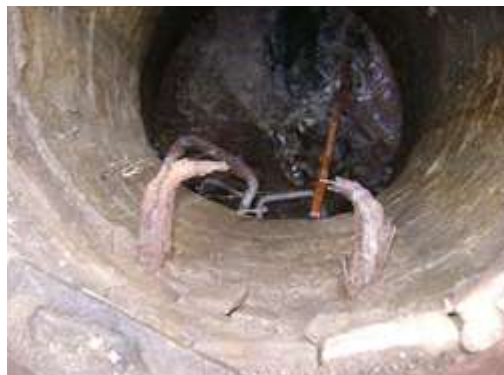
Defect 2

Count: **3** Missing: **2** ☒ **Corroded**

Corrosion on steps.

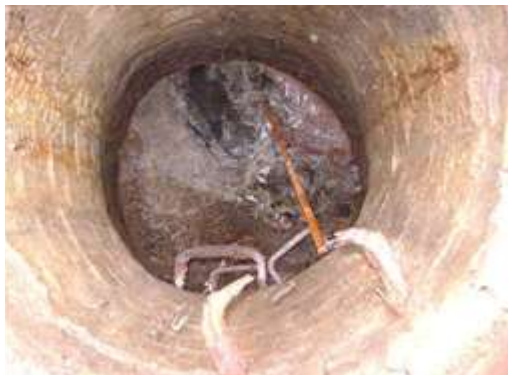
### Defect 1

Condition: ☐ Sound ☐ Cracked ☐ Root Intrusion ☐ Deteriorated ☐ Leaks ☒ **Debris**

Debris in channel and on bench.

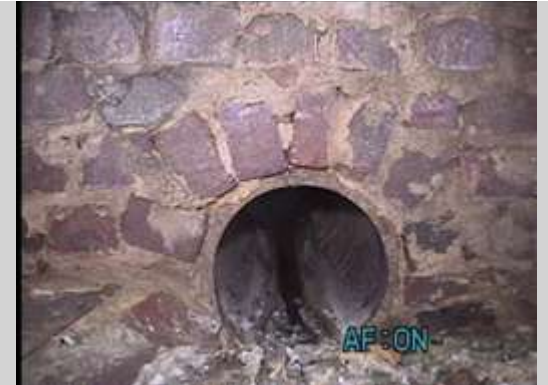
12 O'Clock Outflow

8 in. Circular Gravity Sewer  
Pipe Out @ 12 O'Clock

Pipe Height: **8.4** (in.) Rod and Bar (Angled)  
Pipe Material: **Clay** ☐ Pipe Lined  
Invert Depth: **9.08** (ft.) Flow Characteristics: **None**  
Deposits: ☐ None ☐ Mud ☒ **Gravy** ☒ **Debris** ☐ Grease  
Silt Depth: **1.5** (in.) Deposits Extent: **Medium**  
Infiltration: **None** Pipe Seal Cond: **Sound**

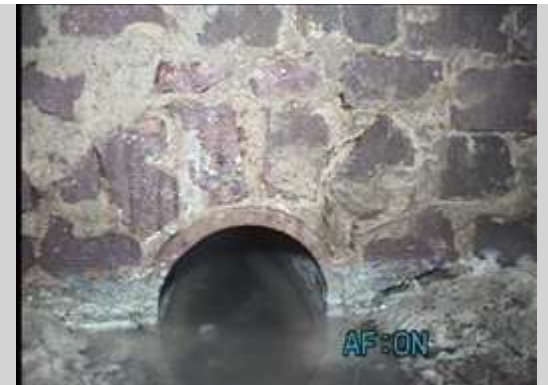
8 O'Clock Inflow

6 in. Circular Gravity Sewer  
Pipe In @ 8 O'Clock

Pipe Height: **6** (in.) Rod and Bar (Angled)  
Pipe Material: **Clay** ☐ Pipe Lined  
Invert Depth: **8.92** (ft.) Flow Characteristics: **None**  
Deposits: ☐ None ☐ Mud ☒ **Gravy** ☒ **Debris** ☐ Grease  
Silt Depth: **1** (in.) Deposits Extent: **Medium**  
Infiltration: **None** Pipe Seal Cond: **Sound**
